Preliminary Results of Post-Disaster Archaeological Investigations at the Kasthamandap and within Hanuman Dhoka, Kathmandu Valley UNESCO World Heritage Property (Nepal)

Coningham, R.A.E.¹, Acharya, K.P.², Davis, C.E.¹, Kunwar, R.B.³, Simpson, I.A.⁴, Schmidt, A.¹ and Tremblay, J.C.¹,

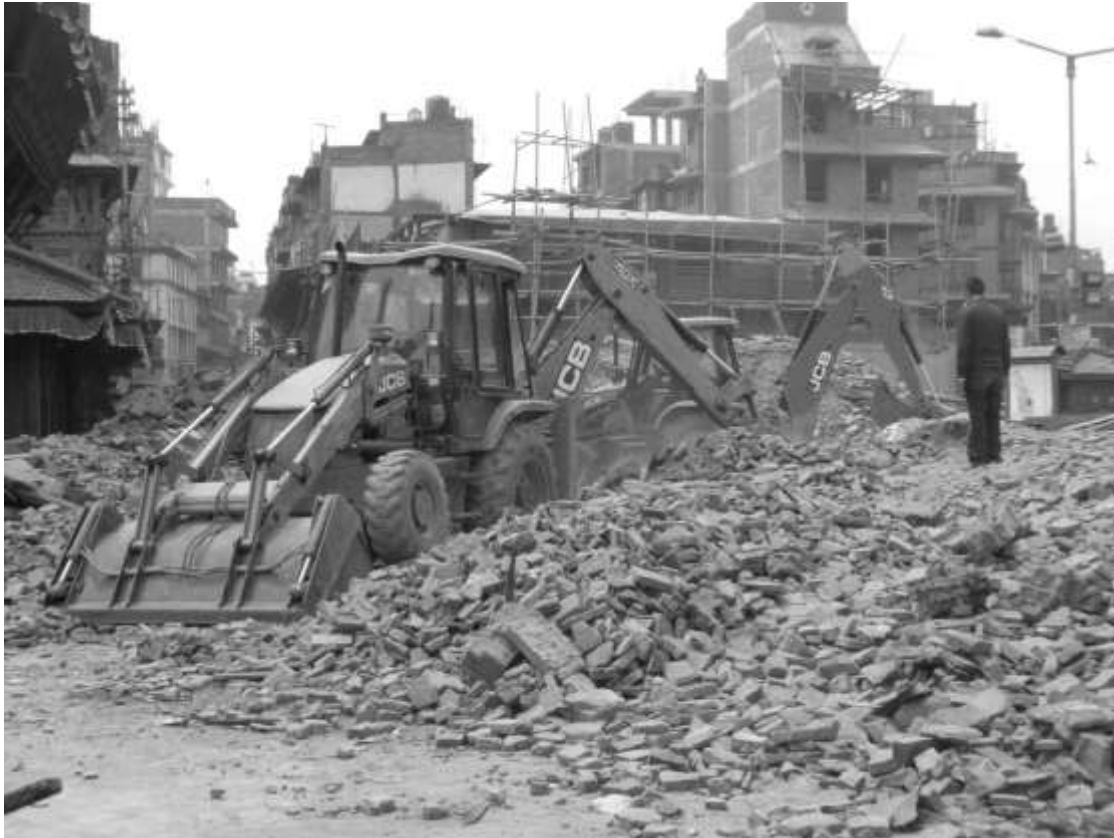
Figure 1: JCBs clearing the debris at Kasthamandap on the 26th April 2015 (Image courtesy of Kai Weise).

During the 7.8 Magnitude Gorkha Earthquake on the 25th April 2015, one of Kathmandu's oldest monuments, the Kasthamandap, collapsed killing over seventy individuals. In the immediate aftermath of the disaster, the army mobilised bulldozers to recover the dead and the injured and the next day two JCBs were deployed on the ruins (Figure 1). Whilst the earthquake caused a catastrophic loss of life and livelihoods across Nepal and surrounding areas, the damage within the UNESCO World Heritage Property of the Kathmandu Valley was particularly bad. Indeed, a number of key monuments within the medieval Durbar Square at Hanuman Dhoka were damaged and many collapsed. In response, a collaborative team of international and national experts from the Department of Archaeology, Government of Nepal, Durham University and the University of Stirling, was invited to participate in a UNESCO-sponsored mission of post-disaster surveys and rescue excavations across earthquake-damaged monuments and areas within the UNESCO Kathmandu Valley World Heritage Property, including Hanuman Dhoka.

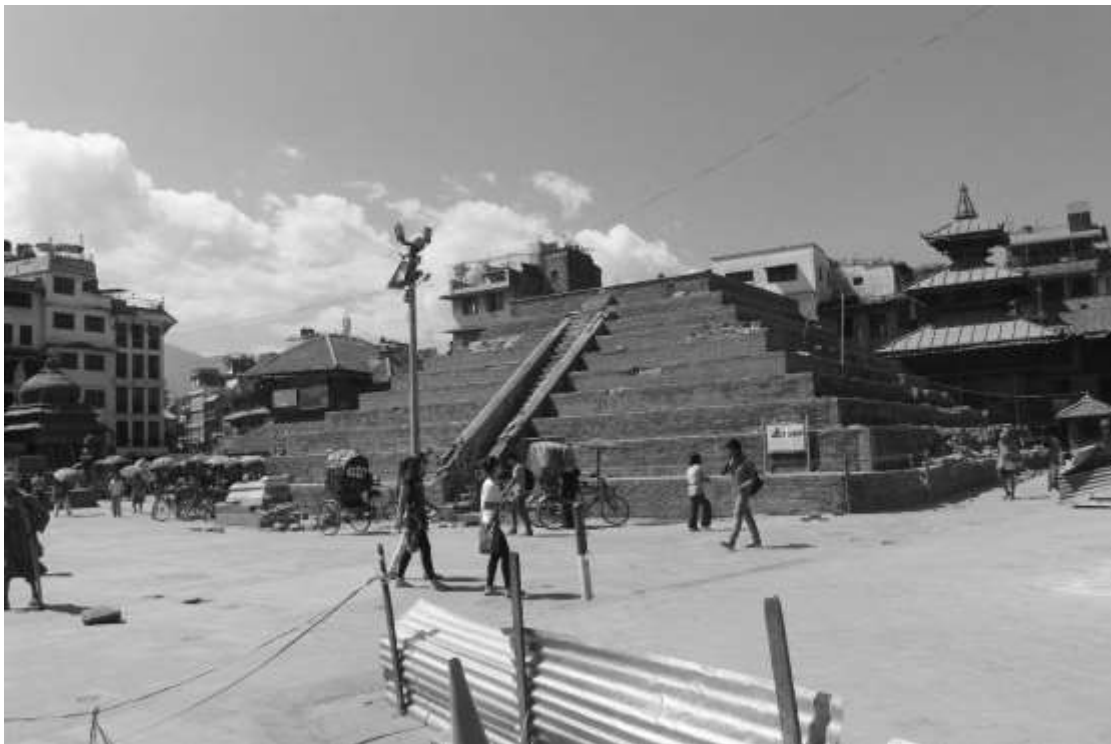
Figure 2: The foundation plinth of the collapsed Maju Degu Temple in Hanuman Dhoka's Durbar Square

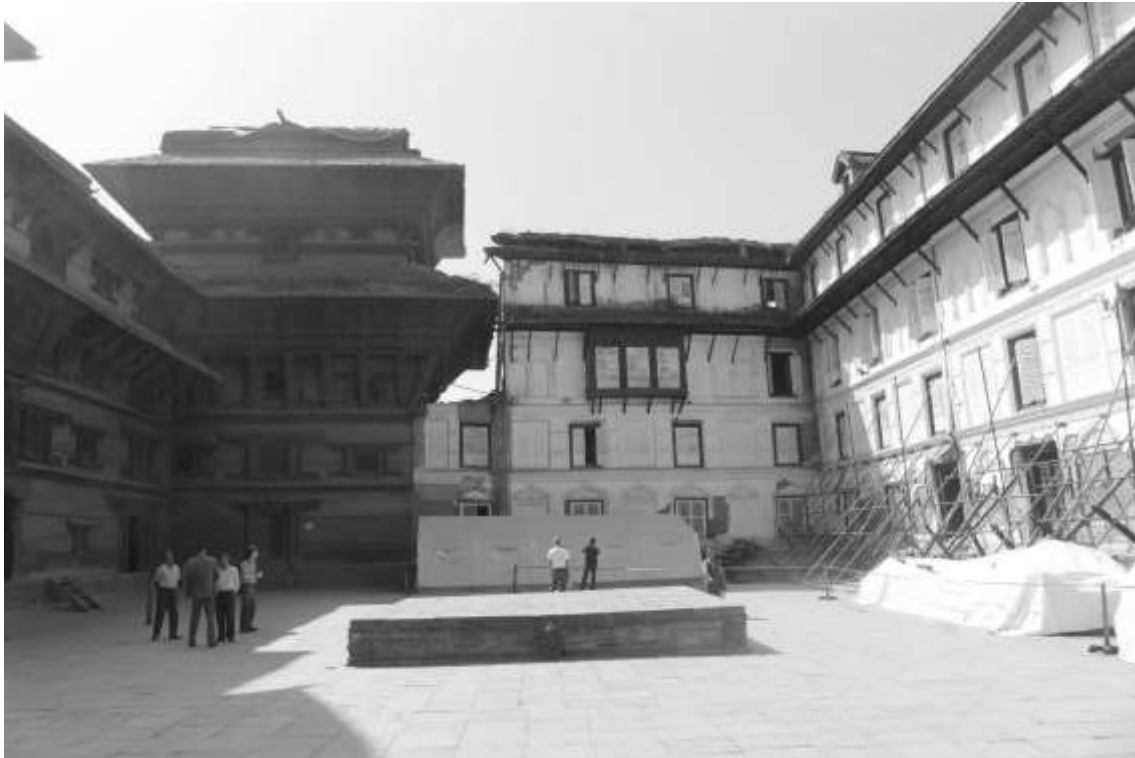
Figure 3: The collapsed Basantapur tower and damage to the interior courtyard at the Palace, Hanuman Dhoka.

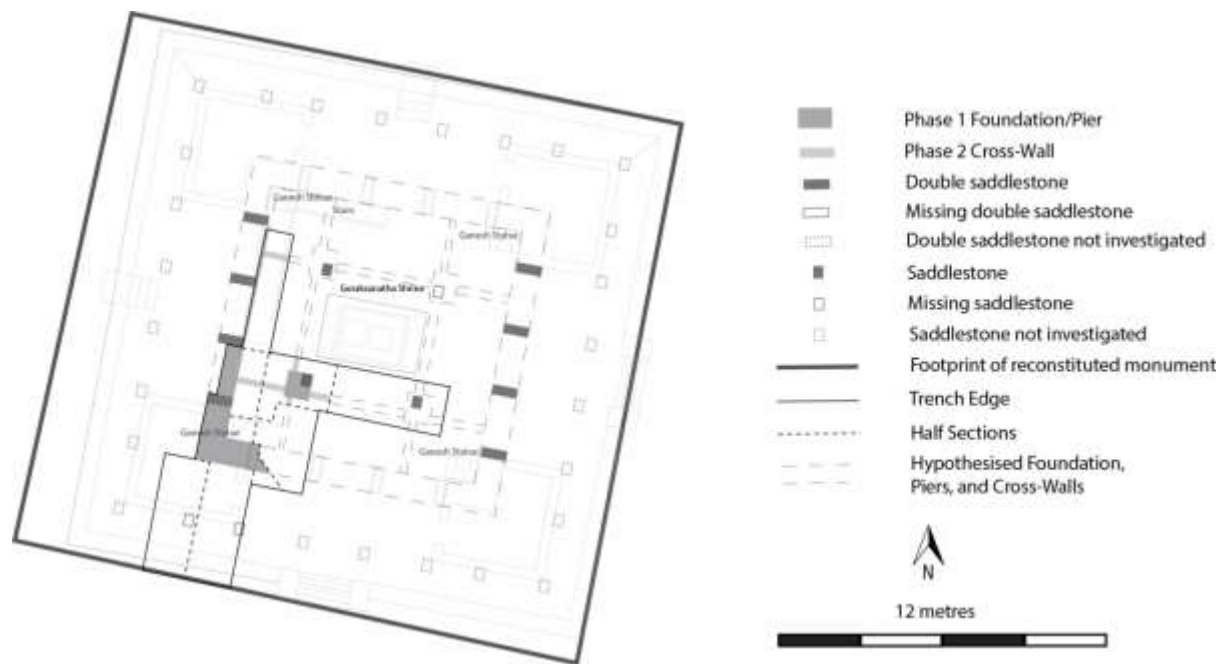
Figure 5: Plan of Trench at Kasthmandap.

In agreement with UNESCO and the Department of Archaeology, Government of Nepal, it was decided that we would excavate within the collapsed remains of the Kasthamandap in order to understand more about its foundation and construction sequence in advance of reconstruction. Therefore, at this location, no excavation was undertaken across the square but such interventions are recommended in future to assess the subsurface heritage of Hanuman Dhoka in tandem with the results from Ground Penetrating Radar survey. The initial trench initially measured four metres east to west and five metres north to south but was later expanded becoming an irregular sized trench measuring 13.90 metres north-south and 10.35 metres east-west at its greatest extent (Figure 5).

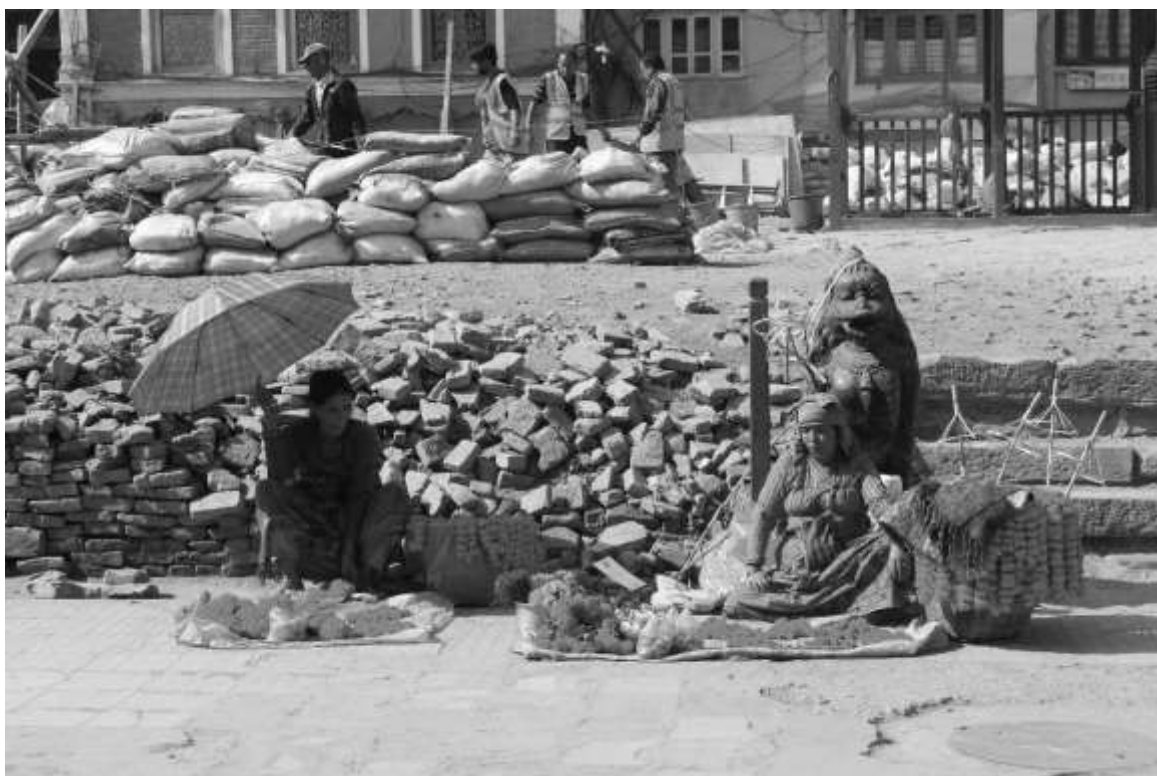
Figure 6: The reconfigured footprint of the Kasthmandap on its eastern edge.

Following the collapse of the Kasthamandap and the subsequent clearance and recovery efforts, the footprint of the monument was reconfigured by volunteers utilising rubble to form a wall where the outer plinth had been bulldozed away. This temporary wall designated a slightly larger area than the original footprint and acted to retain a mixture of brick, tile, stone and concrete behind as well as clay from the roof construction (Figures 6 and 7). Once we had removed the rubble wall from the trench's location, we found evidence of the post-disaster deployment of the JCBs and bulldozers in the form of a very large cut which had removed the southern plinth of the monument as well as in situ subsurface archaeological material originally sealed below its tiled floor. We cleared portions of the remaining tiled surface of the monument, which was covered with debris from the collapse and subsequent clearing by the bulldozer and JCBs. Dating to the 1966 renovation campaign, we found that in places the tile flooring had been damaged by the buckets of the machinery with marks evident in places (Figure 8). We sieved the mixed material from collapse and reconfiguration carefully and recovered tile, brick and carved wood elements as well as modern materials, including surgical gloves, masks, needles and IV lines associated with the blood donation session held at the monument on the 25th April

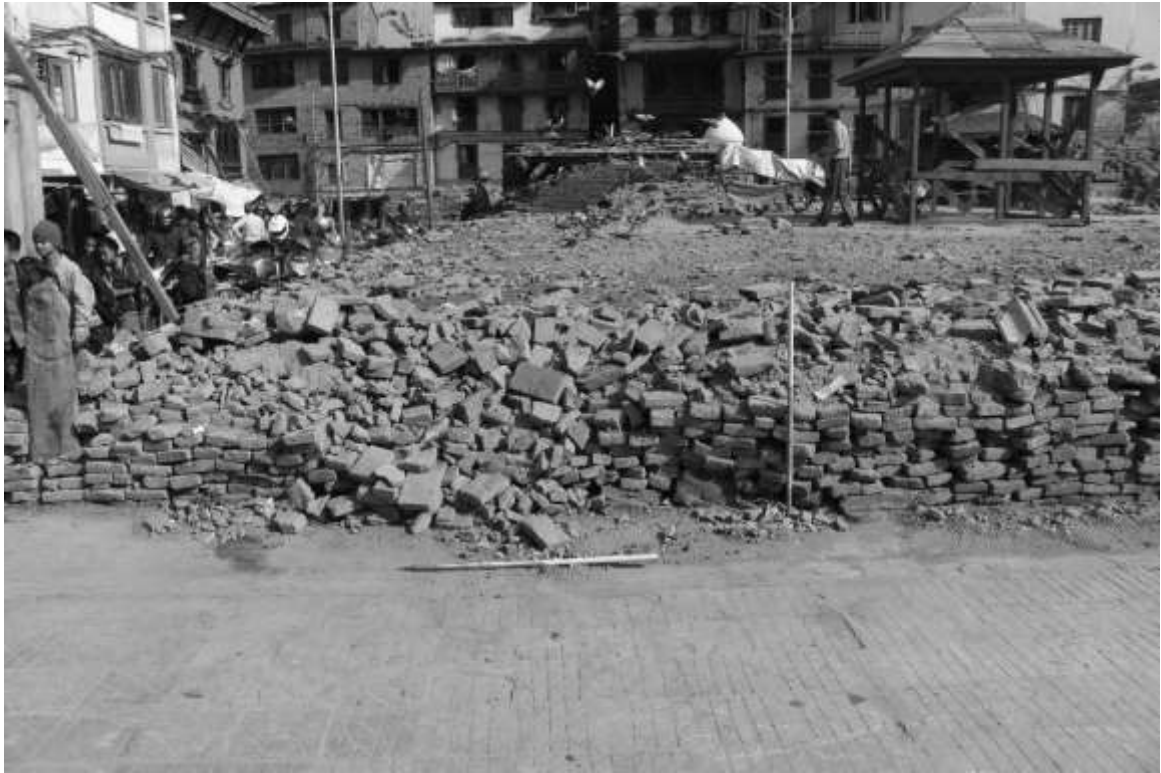
Figure 7: Reconfigured footprint of the Kasthamandap on its southern edge, where the Trench was located.

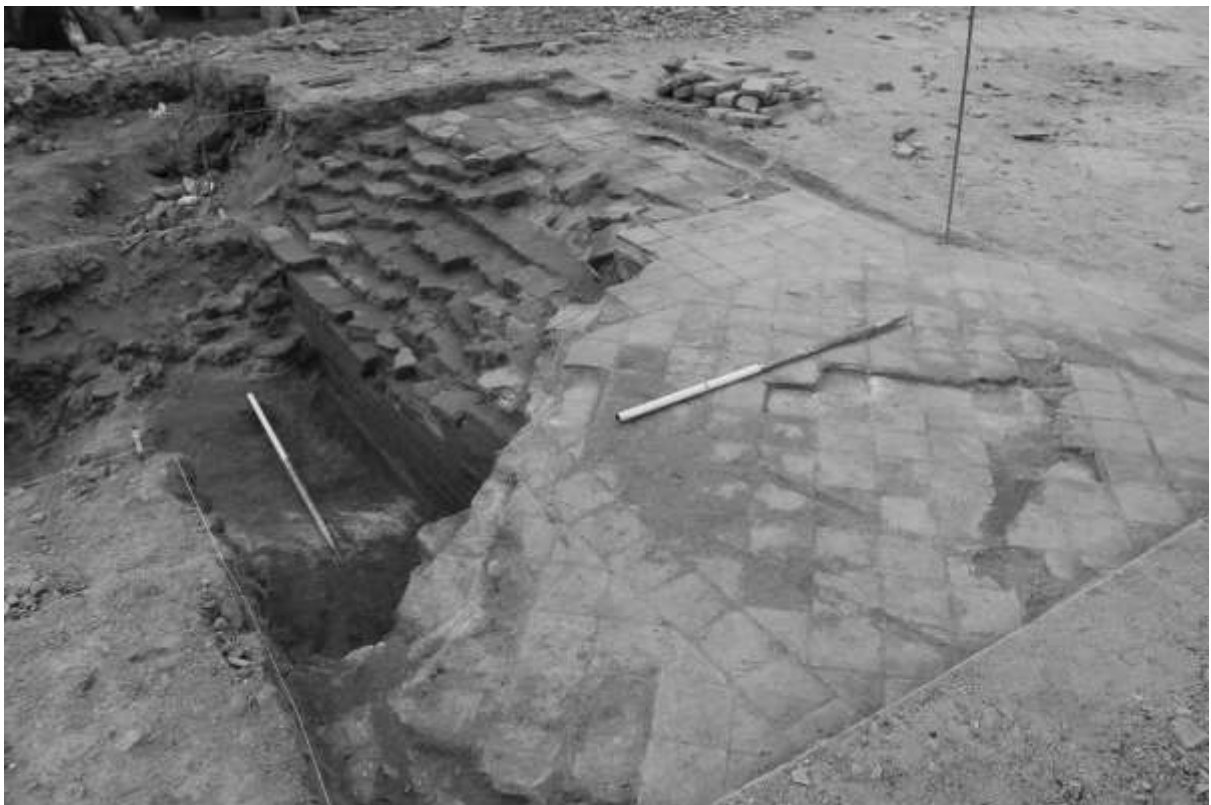
Figure 8: Clear marks from the bucket of machinery on the tiled surface, and cut through this tiled surface and foundation wall below, looking west.

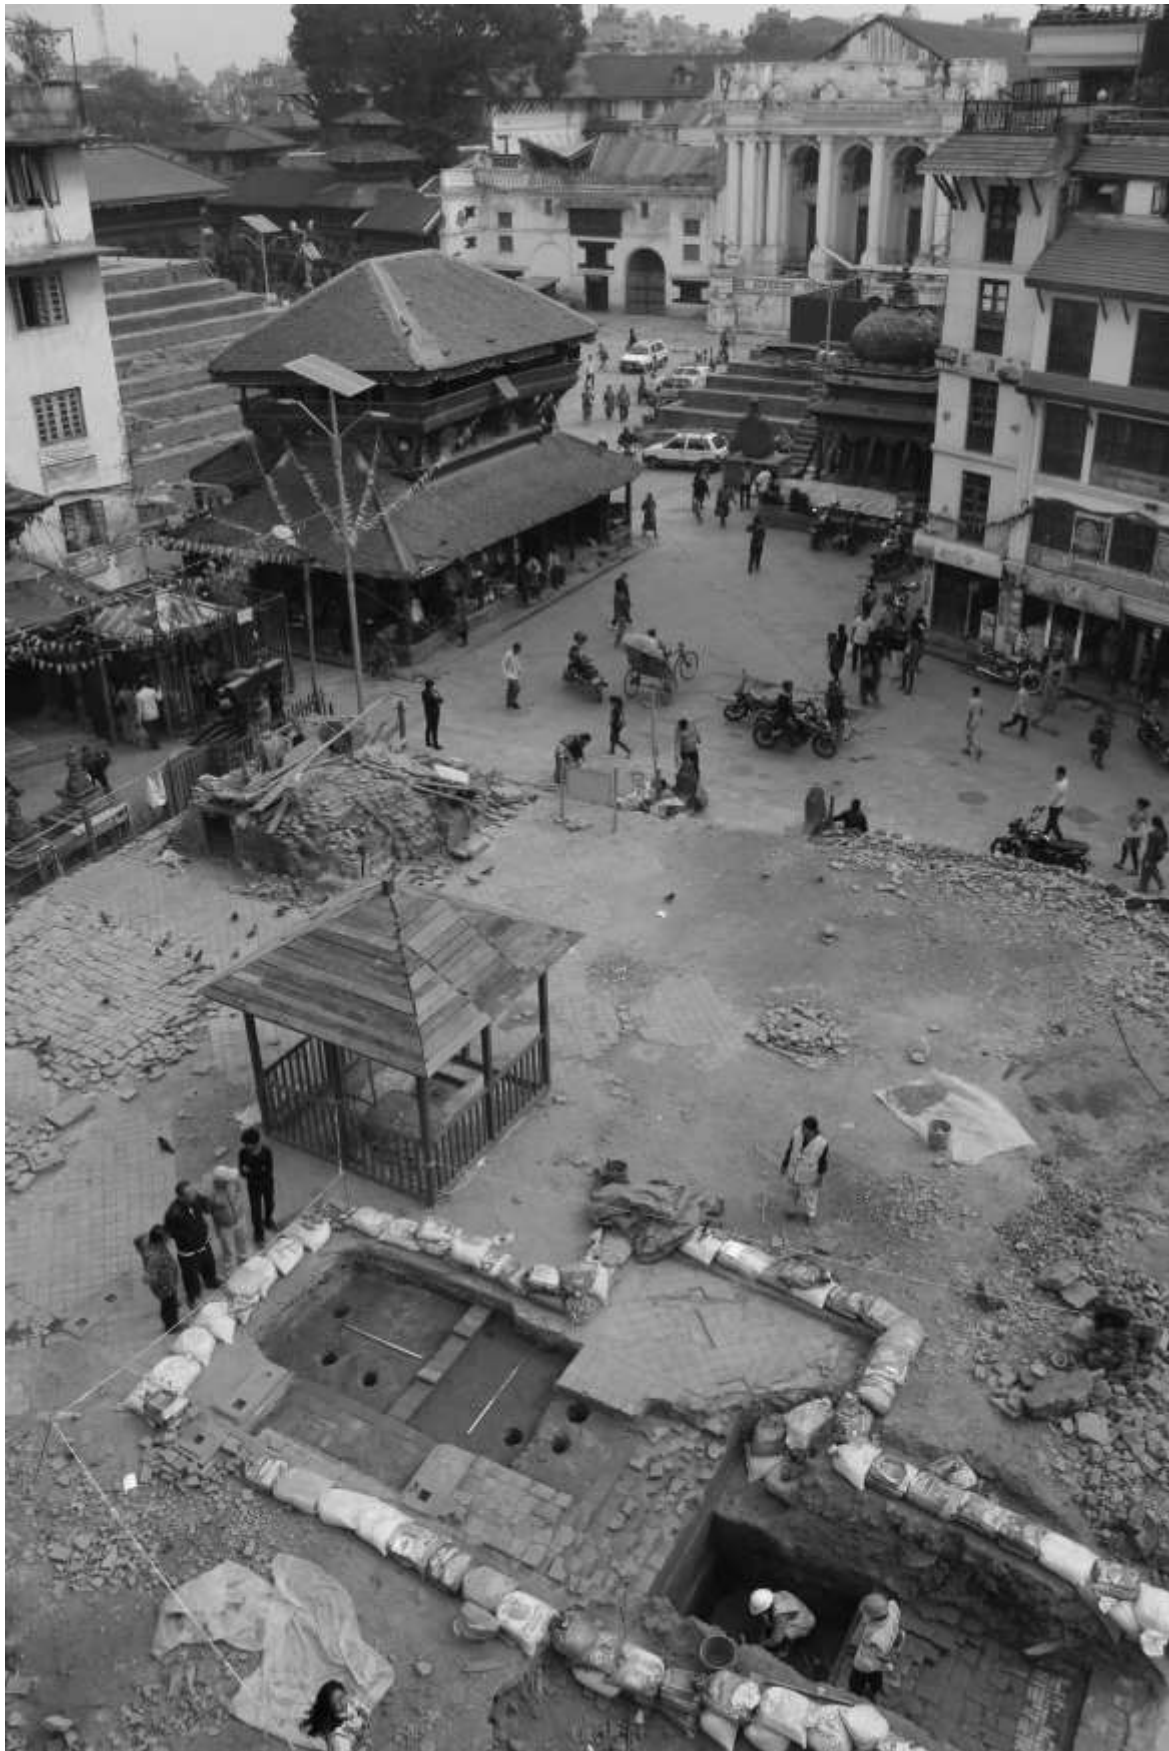
Figure 10: Postholes identified below the tiled surfaces at Kasthmandap, looking east.

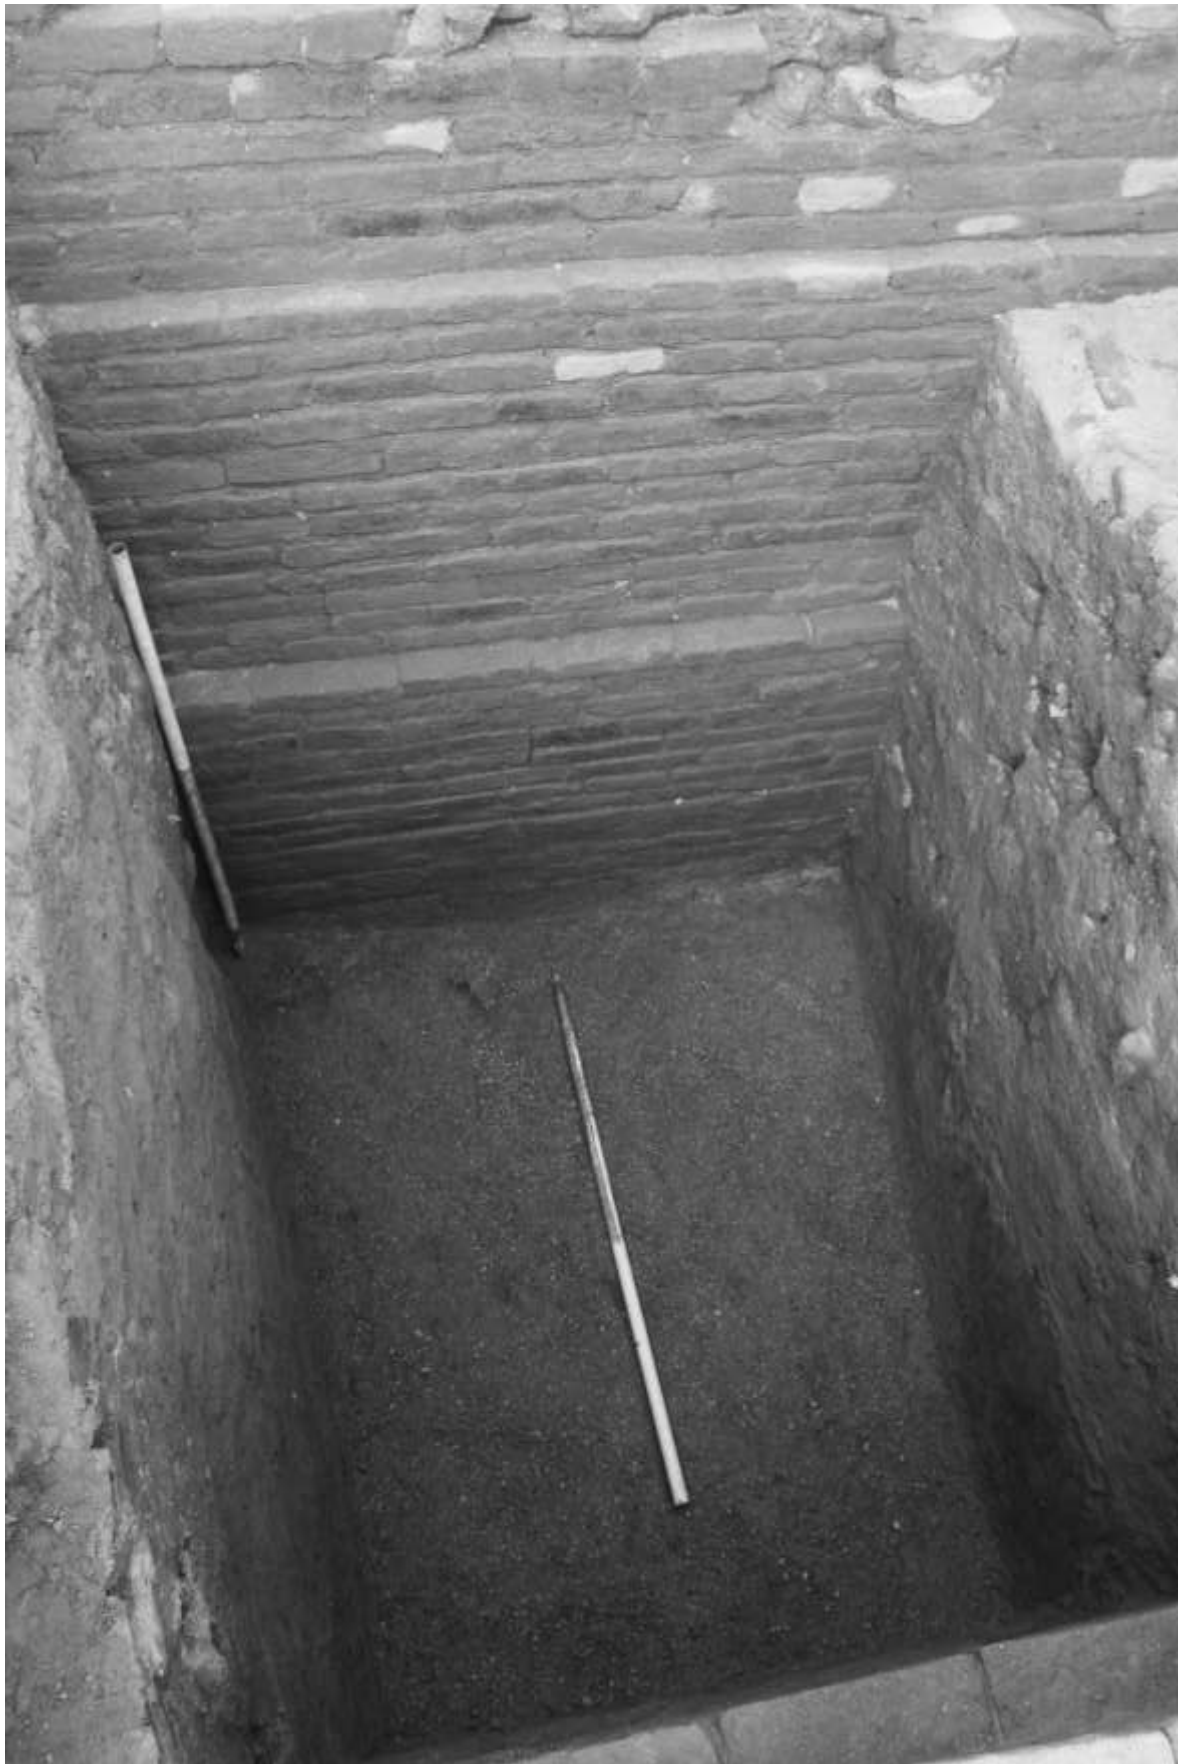
Figure 11: Large foundation wall, looking north.

The most evident of these was the massive one metre thick and two metre deep wall which formed the core foundation for the monument. Indeed, it actually underpinned the apparently independent four L-shaped corner brick quoins and rows of paired saddlestones between them (Figure 11). Measuring an estimated 12 by 12 metres, this exceptionally well-built foundation was constructed of bricks laid in clay mortar. The bonding design of the wall involved placing two stretchers on the prepared ground surface and then following them with two headers, two stretchers and so on. After 12 courses, the wall was stepped and the pattern resumed, comprising three sets of 12 courses. We were unable to identify any signs of damage to this massive foundation relating to the recent or previous earthquakes and the only recorded damage was a direct result of the bulldozers and JCBs during the immediate post-earthquake emergency recovery stage. During the excavation of the lower levels of the wall, it became clear that the foundation wall had been constructed within a cut into underlying clay layers, both cultural and natural, but was only visible to the exterior of the monument.

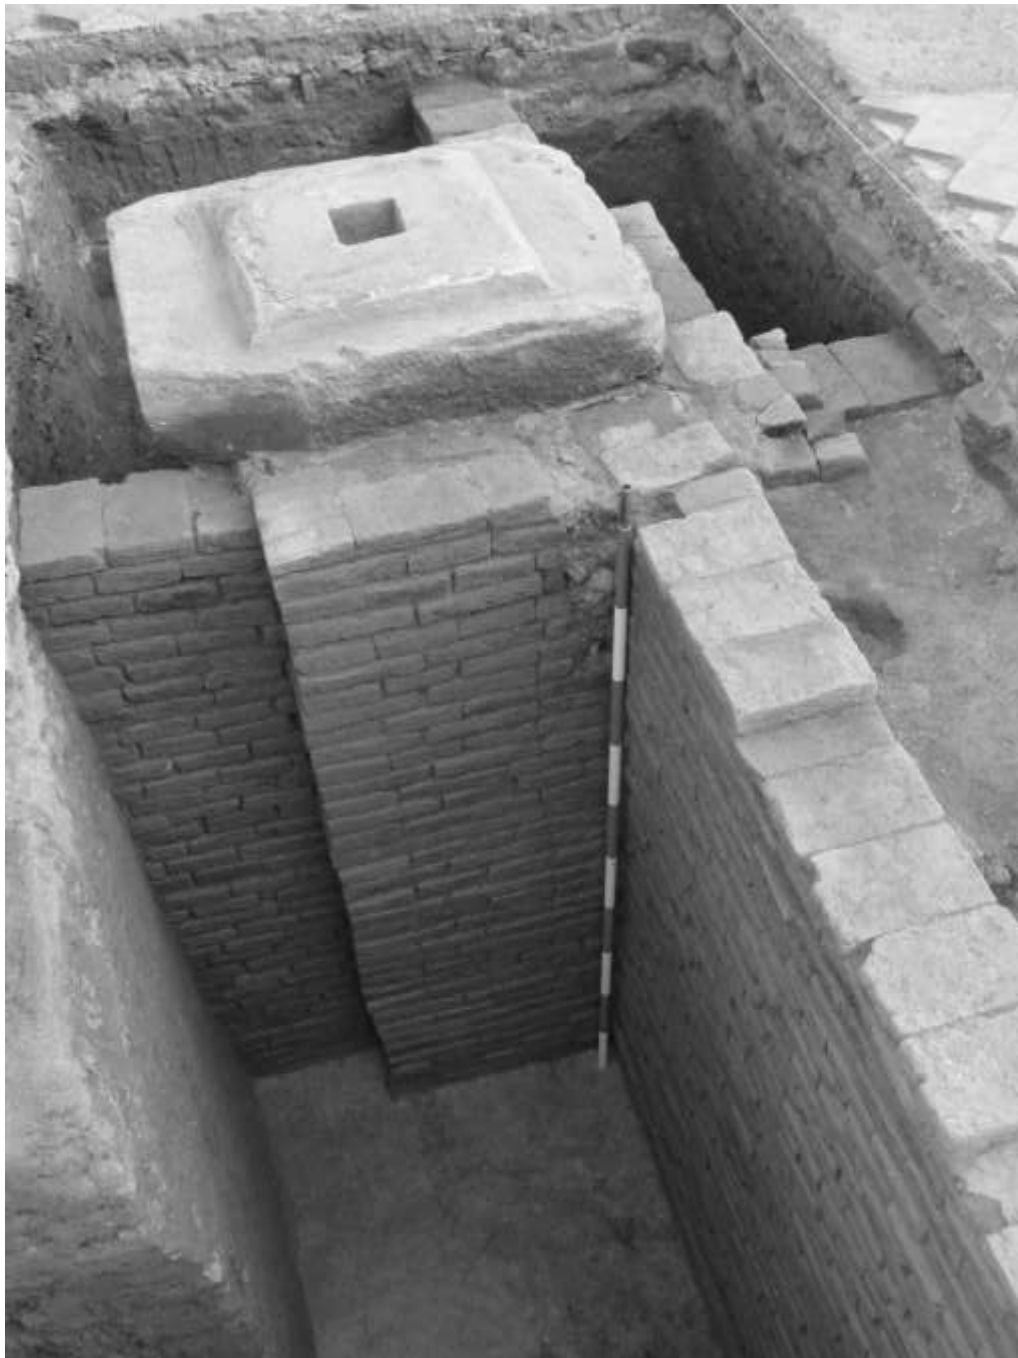
Figure 12: Brick pier below saddlestone, looking east.

When we excavated to the north of this massive wall, in the interior of the monument, we identified a second major construction feature of the original monument – a massive freestanding brick pier. Underlying the large southwest saddlestone, which had supported one of the monument's four central wooden pillars, we exposed the 2.01 metre deep brick pillar with a width of c. one by one metres. Comprising 35 courses of brick set in clay, the exposed brickwork was extremely well preserved and showed no evidence of displacement or earthquake distortion (Figure 12). The brick bond was similar to that of the inner foundation wall and comprised patterns of two headers and two stretchers. Whilst excavating and cleaning these two foundation elements, it became clear that the Kasthamandap had been subjected to a major phase of secondary construction after its original establishment. This had involved the placing of four bracing cross-walls between

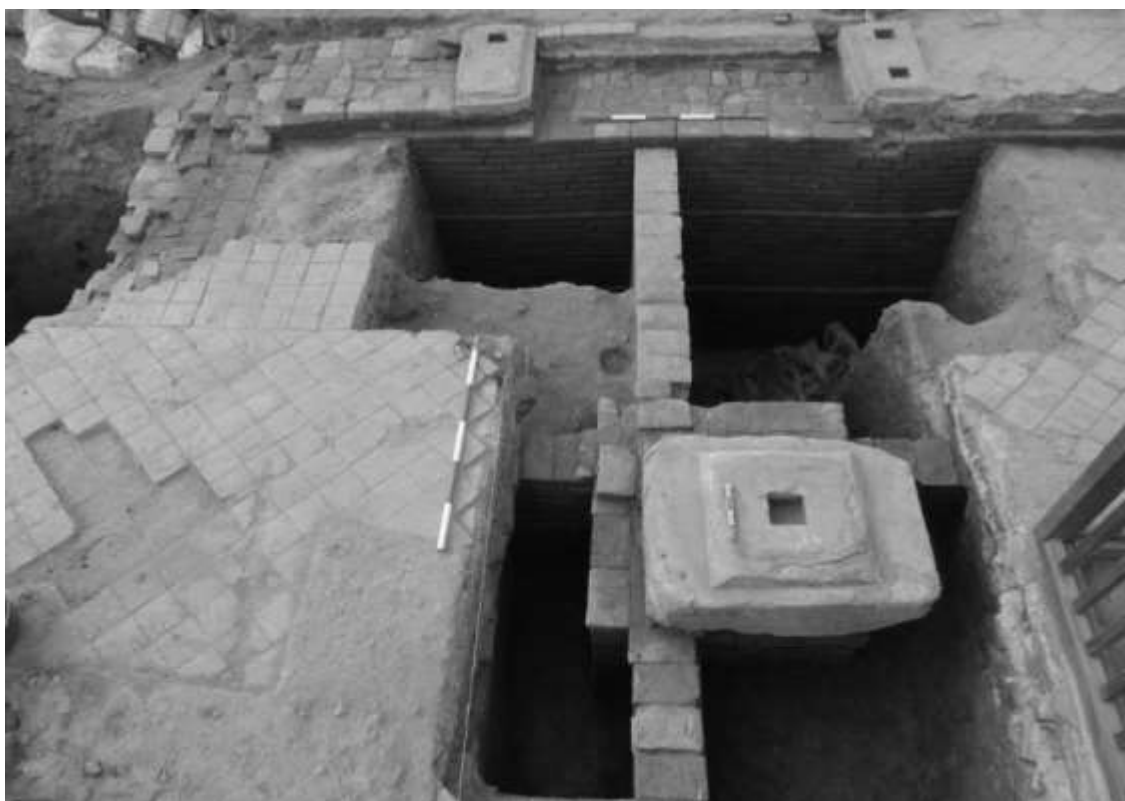
Figure 13: Saddlestone with cross-walls connecting to the brick pier.

the freestanding pier and the massive outer foundation wall and, we assumed, the other piers (Figure 13). These cross-walls were only one brick thick but also went down to the same depth as the original foundations, 2.01 metres. Running between piers and the foundation wall, the cross-walls abutted the main foundation, not cutting into it, and most also abutted the brick pier, though one east-west cross-wall did cut into the upper courses of this pier. Moreover, the bricks were laid in a different bond of only headers.

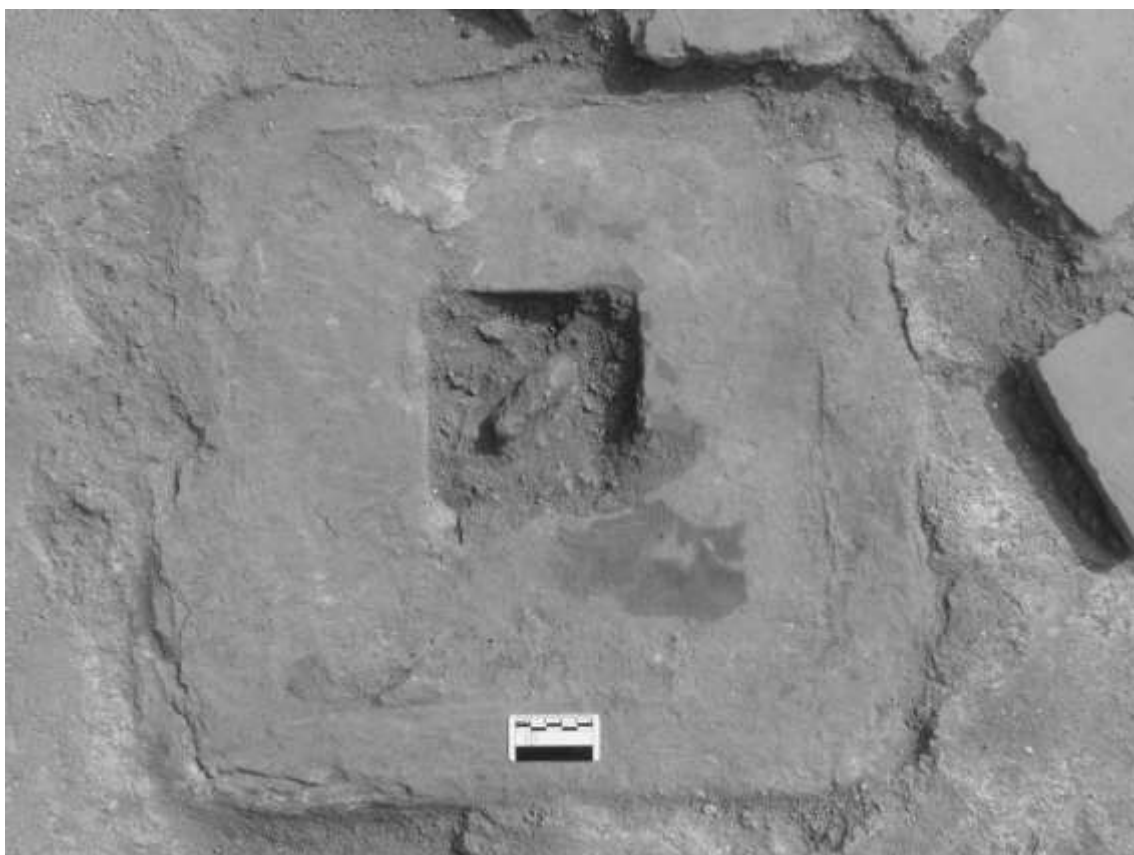
Figure 14: Copper corrosion visible on saddlestone.

The saddlestone measured 0.50 metres square with a raised central square of 0.37 metres. The mortise socket for the wooden pillar's tenon tongue had been cut into the centre of this raised area and measured 0.14 by 0.14 by 0.14 by 0.135 metres and 0.06 metres deep. The presence of a roughly square copper alloy residue on the raised square portion of the saddlestone suggests that original wooden pillar was separated from its saddlestone by a copper alloy plate, perhaps acting as a damp proof course (Figure 14). Indeed, we identified one of the original central timber pillars from the Kasthamandap within the Durbar Square and found that it measured 6.2 metres long and 0.39 square. At the upper end of the pillar, it was equipped a 0.13 metre deep mortise socket and at the base of the pillar with a 0.07 metre long tenon tongue measuring 0.12 by 0.11 metres. This indicates that wooden tenon and stone mortise joint was designed to leave a small gap between the two, again perhaps a way of preventing moisture from leading to the rotting of the base of the timber pillar.

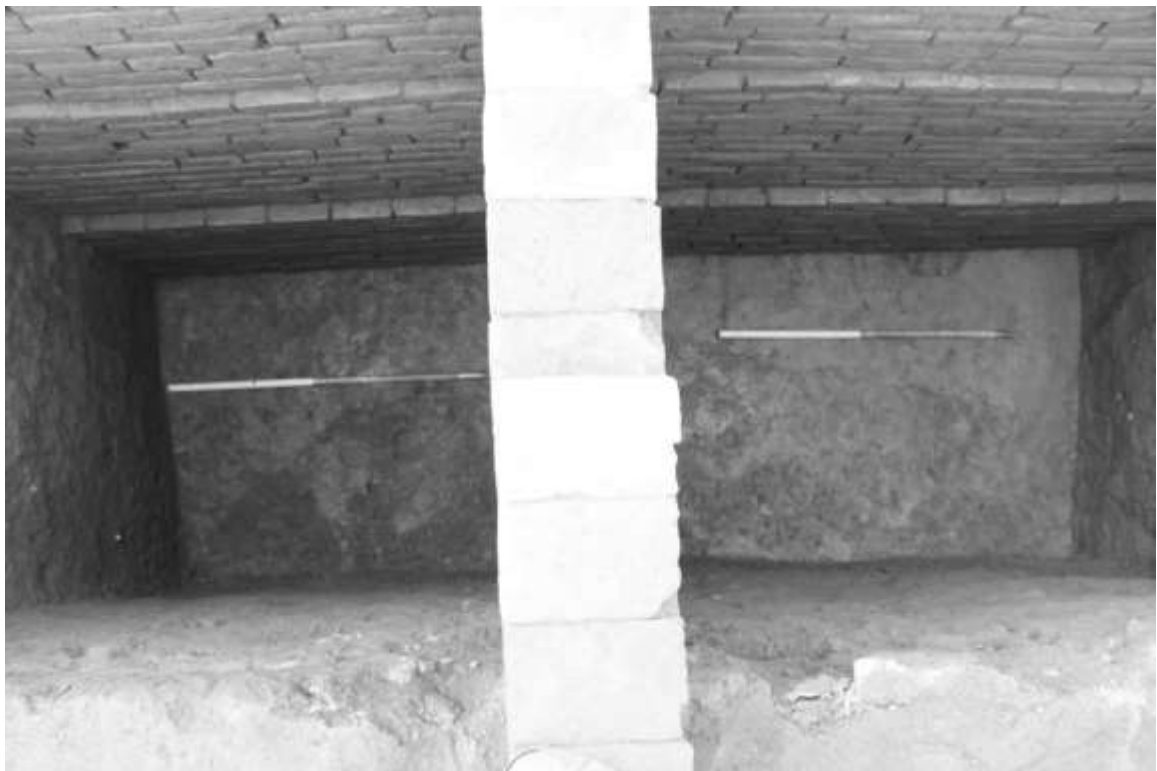
Figure 16: Rounded feature visible below eas-west cross-wall within large foundations of Kasthamandap, looking west.

At the base of the cross-walls, brick pier and large foundation wall we identified evidence of pre-monument construction human activity. Below the homogenous fill material that was deposited within the cross-walls and foundation, was a smooth clay that might represent the natural. This ran underneath the cross-wall east-west cross-wall within the larger area of the trench. Very clearly, a rounded feature also cut into this material, to the east of the trench. Cut into the sterile clay, this feature contained inclusions of charcoal and ceramics. It was not fully excavated as water was reached at this depth and waterlogging also caused concerns of undermining the cross-wall and damaging the architectural integrity of the Kasthamandap foundations. This feature indicated that there was cultural activity at the site prior to the construction of the brick walls at the site (Figure 16)

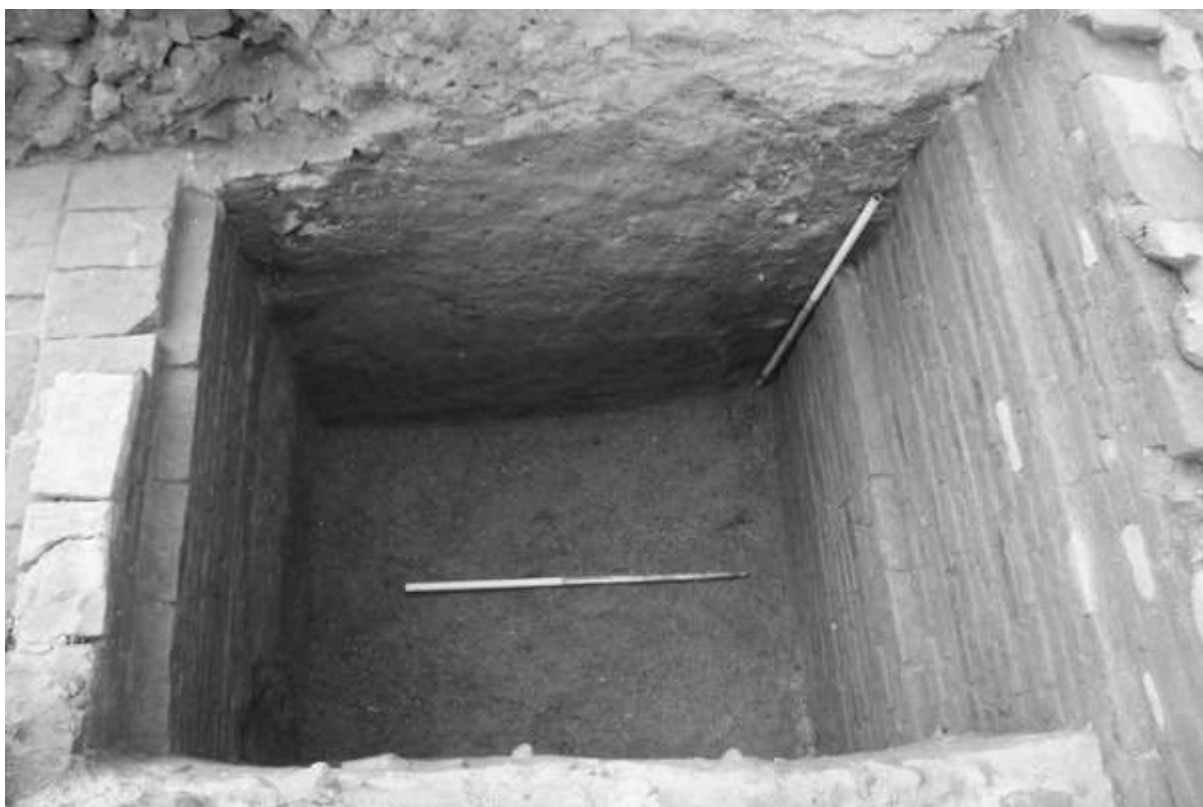
Figure 17: Earlier deposits in the east-facing section, cut by both the foundation wall (north) and exterior wall (south).

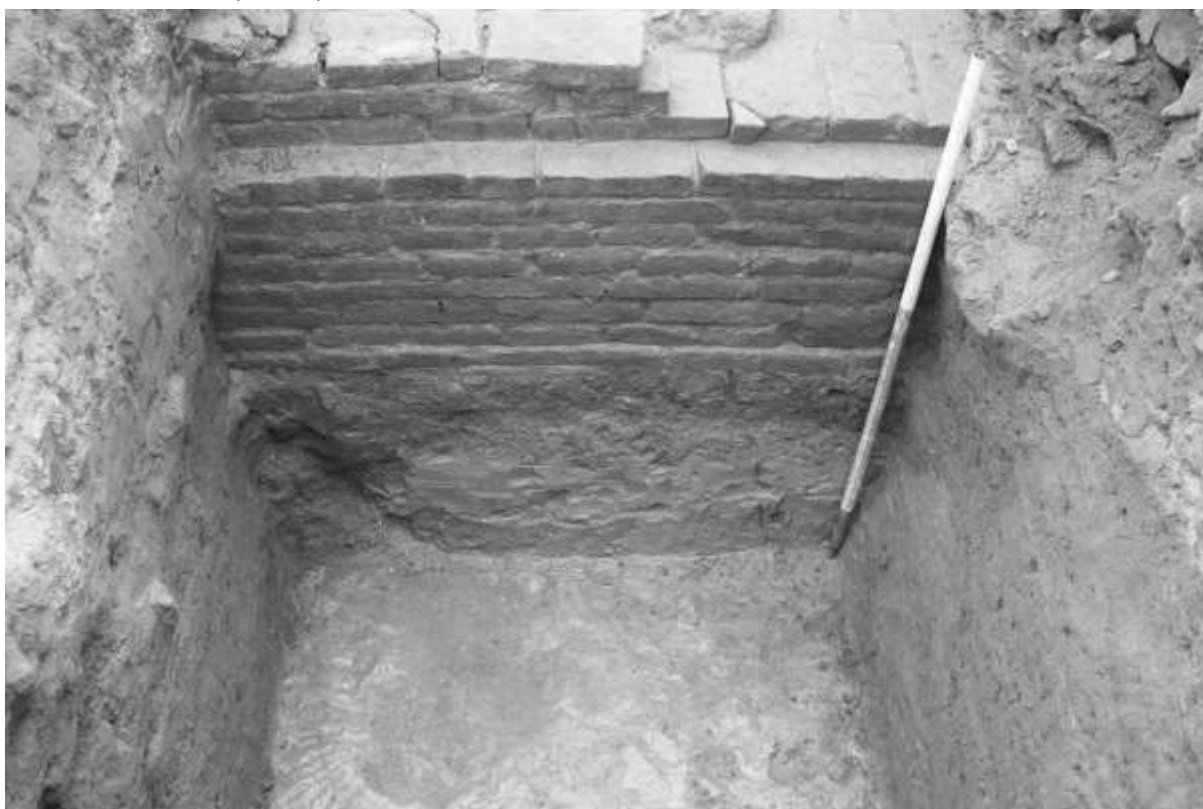
Figure 18: Brick wall to the south of the foundations of the Kasthamandap, looking south.

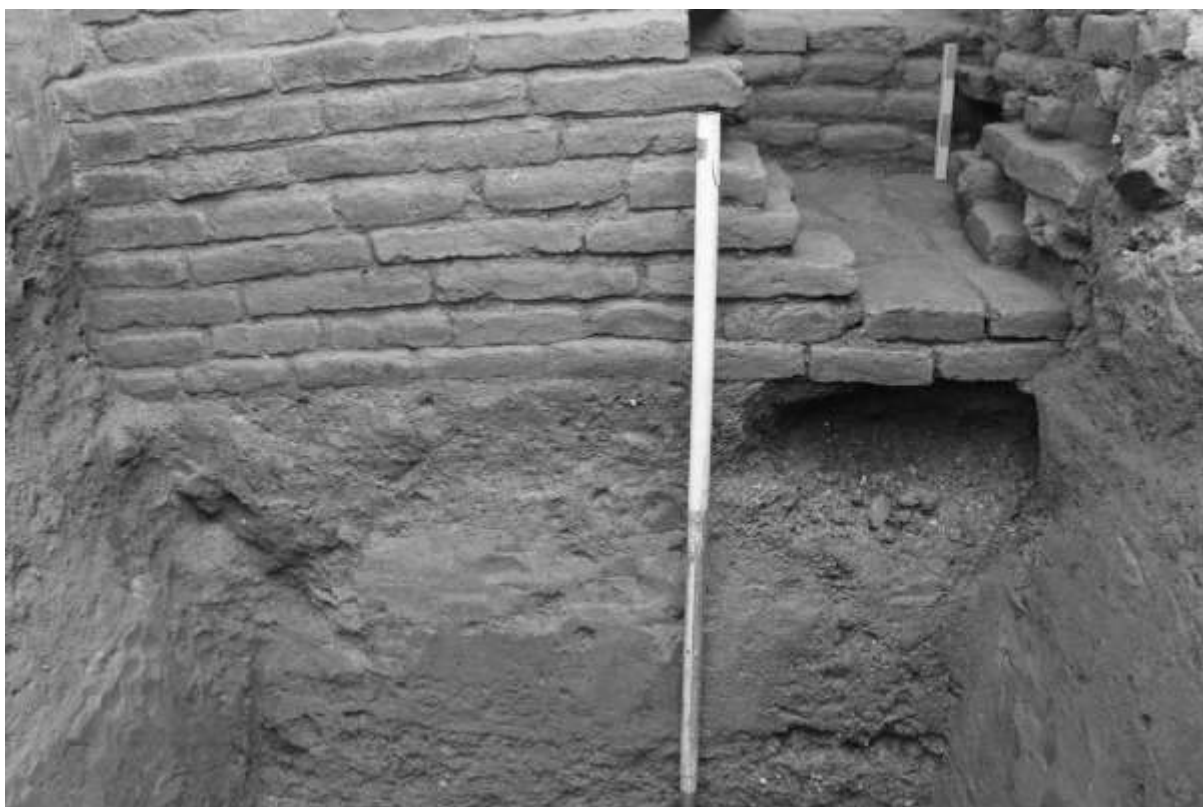
Figure 19: Exterior wall cut through to show an other phase of walling further to the south.

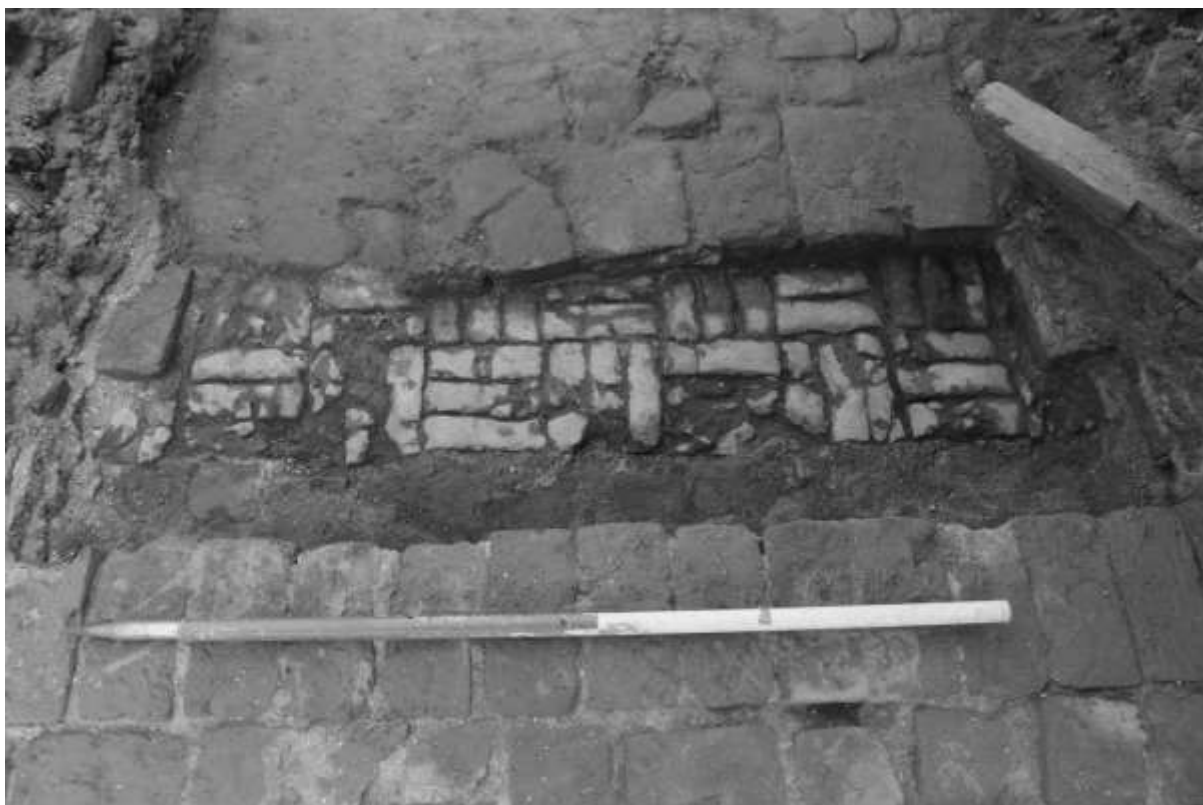
Figure 20: Basket-weave pavement found below the modern brick plinth, looking north.

The area of the trench to the south of the massive foundation wall was much less well preserved due to the extensive damage from the JCBs and bulldozers and we estimate that some 30% of the monument was destroyed during the initial two day post-disaster recovery stage. As mentioned above, the southern side of the 12 by 12 metre foundation wall had been partly damaged by machinery which had cut down through the monument's tiled floor damaging much of the in situ archaeological deposits below. We were, however, still able to identify that the base of the foundation wall had been cut down into underlying cultural and natural deposits (Figure 17). These clearly layered deposits were truncated on the north by the massive foundation wall and on the south by another brick wall, marking the southern edge of the Kasthamandap's massive platform (Figure 18). Surviving to a maximum height of 11 courses, the outer wall's bond was the same as that of the inner foundation wall and we assume that both were constructed at the same time. However, whilst the inner wall was remodelled, there is no evidence of the material between the inner and outer walls being removed as it still preserves in situ archaeological deposits. This is not to suggest that the outer wall has not been remodelled as we identified at least two phases to its one metre thickness (Figure 19). This indicator of the southern edge of the monument was later augmented by a modern brick plinth which preserved below it a worn portion of the original basket-weave pattern of the old brick paved Durbar Square (Figure 20).

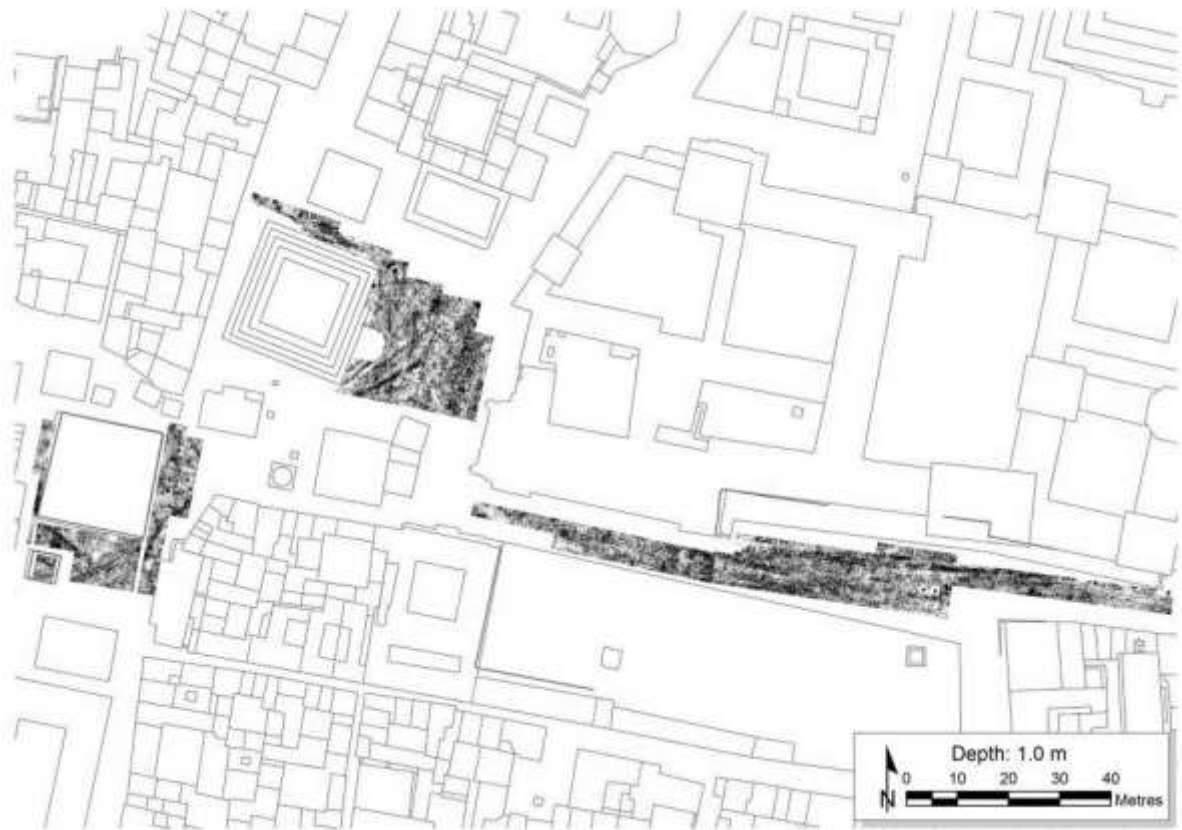
Figure 21: GPR survey results across Hanuman Dhoka's Durbar Square at a 1 metre depth.

GPR survey was commenced across 2,009 square metres of Hanuman Dhoka's Durbar Square and a total of 80,360,000 individual data values were recorded in 13 survey areas to a depth of two metres. We used a Mala GPR system to investigate, comprised a X3M control unit, a XV data monitor, a 500 MHz shielded antenna and a Rough Terrain Cart. Three areas within Hanuman Dhoka were investigated with Ground Penetrating Radar

(GPR): (a) around the Kasthamandap; (b) east of the Maju Dega Temple, up to the palace; and (c) south of the palace complex (Figures 21 and 22). The GPR results next to the Temple and Kasthamandap are dominated by linear anomalies that are all interpreted as modern utilities, either for freshwater, sewer or electric cables. Unlike in Bhaktapur (Coningham et al. 2016a), the anomalies show as strong reflections (black) and it is hence assumed that the pipes themselves are imaged. All extended anomalies next to these linear features are also interpreted to be of modern origin, probably forming the interconnection of structures for the utilities. Some of these coincide with metal man-holes or grills that were noted during the Total Station survey. In the southern part of the Maju Dega area, several of these linear anomalies appear interrupted for no apparent reason.
